Report No. FAA-RD-71-3

# **TITANIUM FUSELAGE ENVIRONMENTAL CONDITIONS IN POST-CRASH FIRES**

**Constantine P. Sarkos**  
National Aviation Facilities Experimental Center  
Atlantic City, New Jersey 08405

**MARCH 1971**

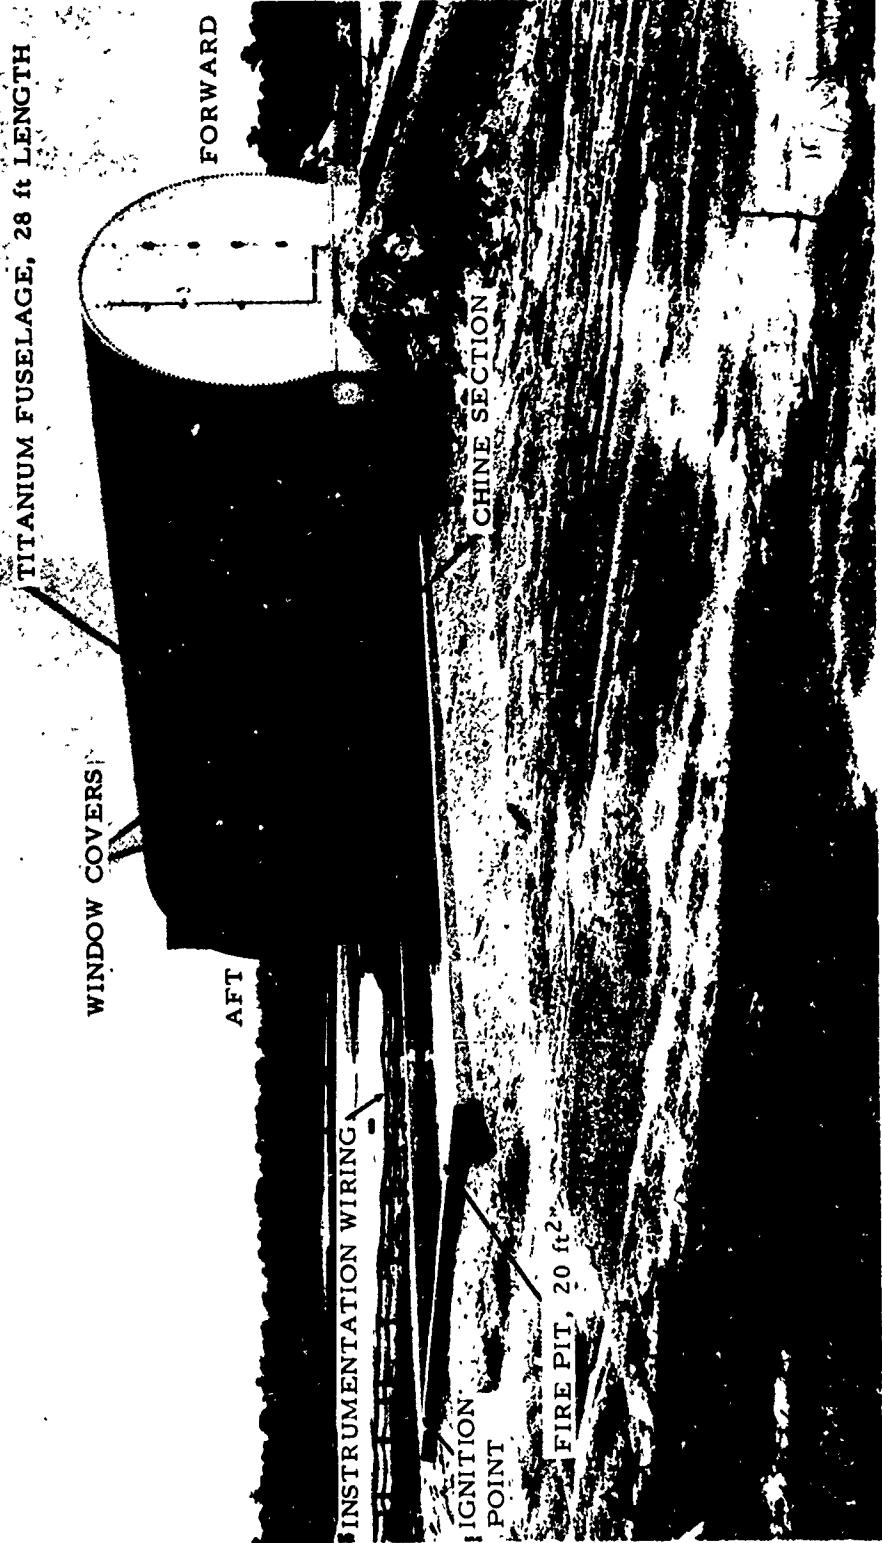
FIGURE 1 - TITANIUM FUSELAGE AND ADJACENT FIRE PIT

During competition for the SST contract, one bidder constructed a 28-foot titanium mockup of the SST in order to test its proposed environmental control system. After the contract was awarded, this fuselage became surplus equipment and was eventually shipped to NAFEC for testing under this project. The fuselage was primarily constructed of two titanium alloys: the outer skin was made of Ti-8Al-1Mo-1V, and the structural members were made of Ti-6Al-4V. Figure 1 shows the fuselage at the NAFEC fire test site.

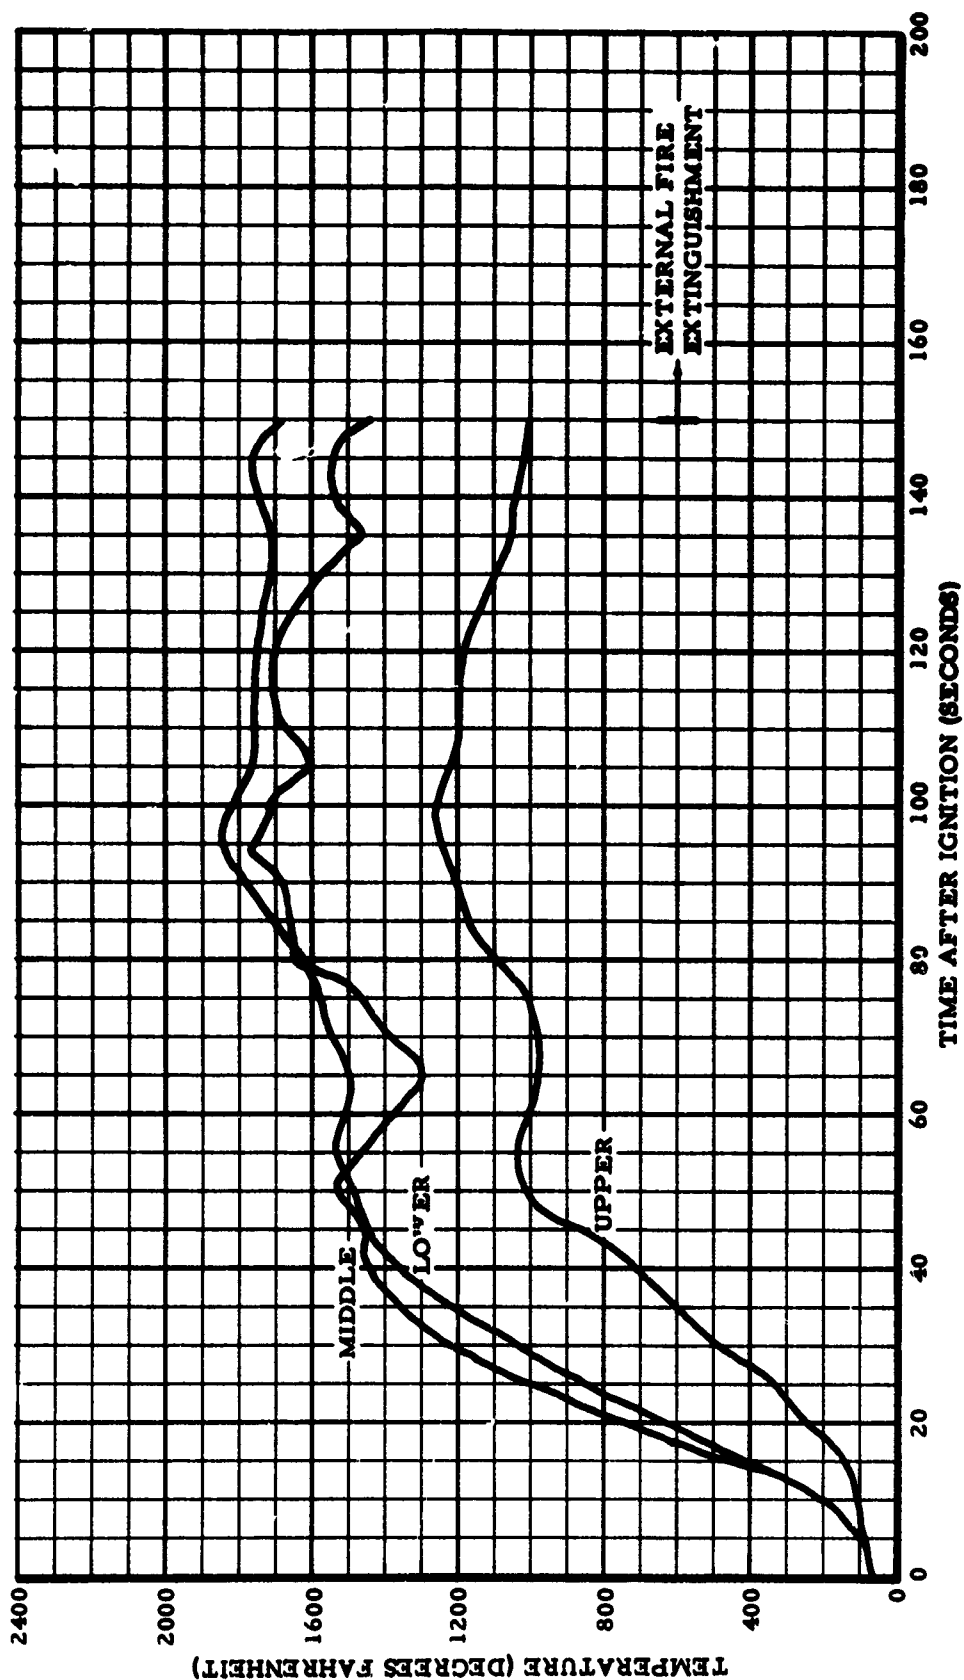
FIGURE 23 - TITANIUM FUSELAGE SKIN TEMPERATURE (CENTER SECTION) DURING AN EXTERNAL FUEL FIRE

The titanium skin temperatures at the center section are shown in Figure 23 for the three measurement levels. The middle and lower temperatures were fairly similar, while the upper temperature was substantially lower, indicating that flame bending around the fuselage was not significant enough to raise the upper fuselage skin temperatures to the values experienced by the areas adjacent to the fire. This trend was also exhibited by the aft and forward sections, although the forward temperatures were significantly lower than either the center or aft temperatures. Since an aluminum alloy melts over a temperature range extending from about 900° to 1200°F (Reference 2), the skin of a conventional subsonic aircraft experiencing the same temperature history shown in Figure 23 would melt in less than 30 seconds at some areas and allow fire entry into the cabin interior.

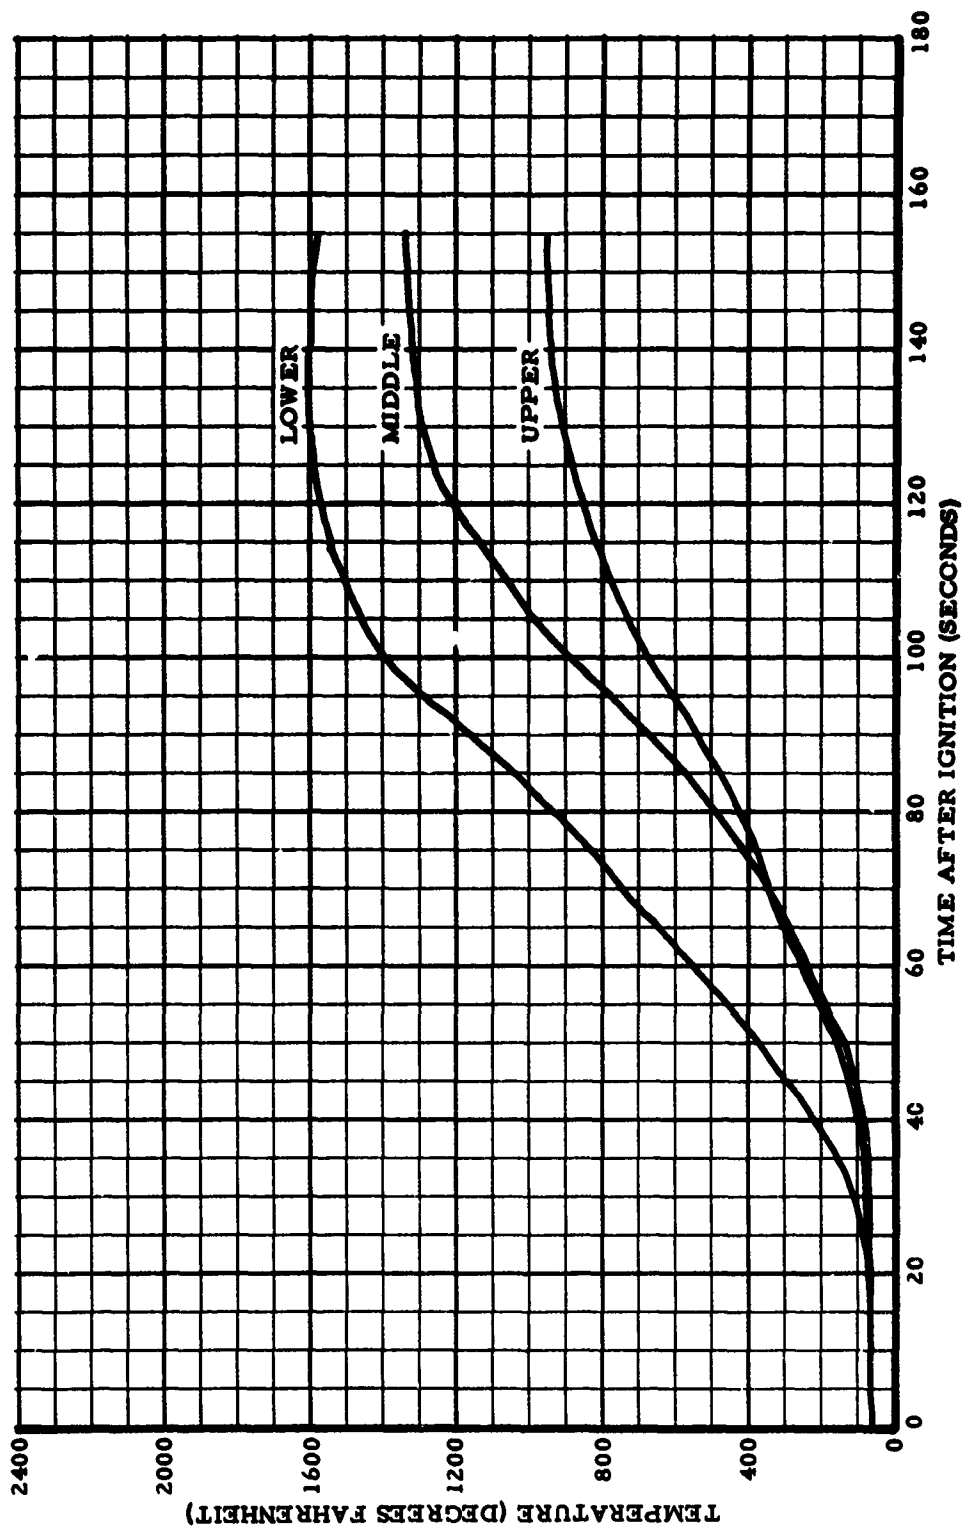
FIGURE 24 - TITANIUM FUSELAGE STRINGER TEMPERATURE (CENTER SECTION) DURING AN EXTERNAL FUEL FIRE

The structural members of the titanium fuselage did not heat up nearly as rapidly as the skin. In fact, the maximum increase in former temperature was only 30°F. This was due to the large heat capacity of the former and somewhat, perhaps, due to the location of the thermocouple on the inside flange of the former (Figure 7). Since the stringers were not nearly as massive as the formers, they were heated much more rapidly than the formers were, and the stringer temperatures eventually reached the titanium skin temperature by the end of the test. Figure 24 compares the measured stringer temperatures at the center section and is representative of the trend exhibited by the other two sections; i.e., the stringers located closest to the fire pit experienced the greatest heating. The temperatures of the three instrumented stringers increased towards the aft end of the fuselage, except for the upper stringer at the center section where the temperature exceeded that at the aft end. Since a comparison of the stringer temperatures gives a relative indication of the amount of heat transmitted through the titanium skin, it is not surprising that the location of the highest stringer temperatures coincided with the fuselage areas which experienced the most severe burning of RTV sealant and insulation.

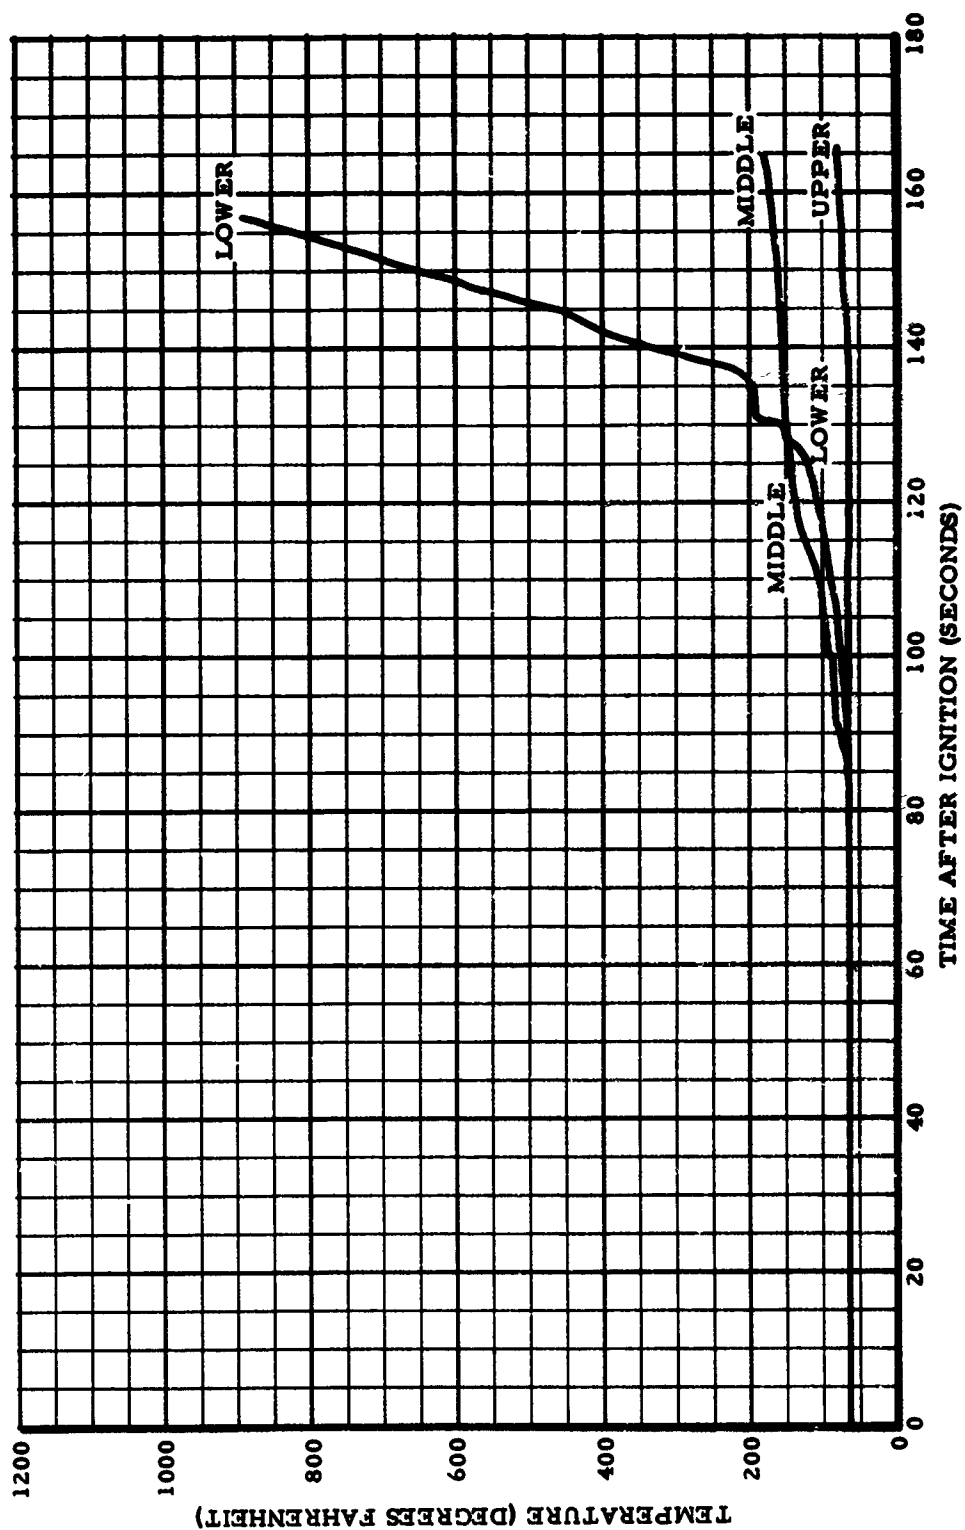
FIGURE 25 - TITANIUM FUSELAGE INSULATION TEMPERATURE (CENTER SECTION) DURING AN EXTERNAL FUEL FIRE

The heat transmitted through the titanium skin was impeded by the insulation batts, and from the preceding discussion, one would expect the insulation temperature at different levels to follow the same trends as the stringer temperature. Figure 25 shows that this was not the case. The middle temperature unexpectedly exceeded the lower temperature until about 130 seconds after ignition, probably because the middle thermocouple was feeling the heat from the combustion of the RTV silicone sealant. (The middle insulation thermocouple was located adjacent to an RTV-covered doubler section, while both the lower and upper thermocouples were not.) Because of the greater heat transfer at the lower level, the insulation there eventually ignited and burned, as indicated by the sharp and initially erratic increase in temperature starting at 125 seconds after ignition. Since both the middle and upper thermocouples did not experience any sharp increases in temperature which are characteristic of flaming, the thermocouple data were thus consistent with the appearance of the center section (Figure 20). All three aft insulation thermocouples showed sharp increases in temperature indicative of burning insulation, the remnants from which were observed in Figure 17. The insulation temperature of the forward section did not change throughout the test.

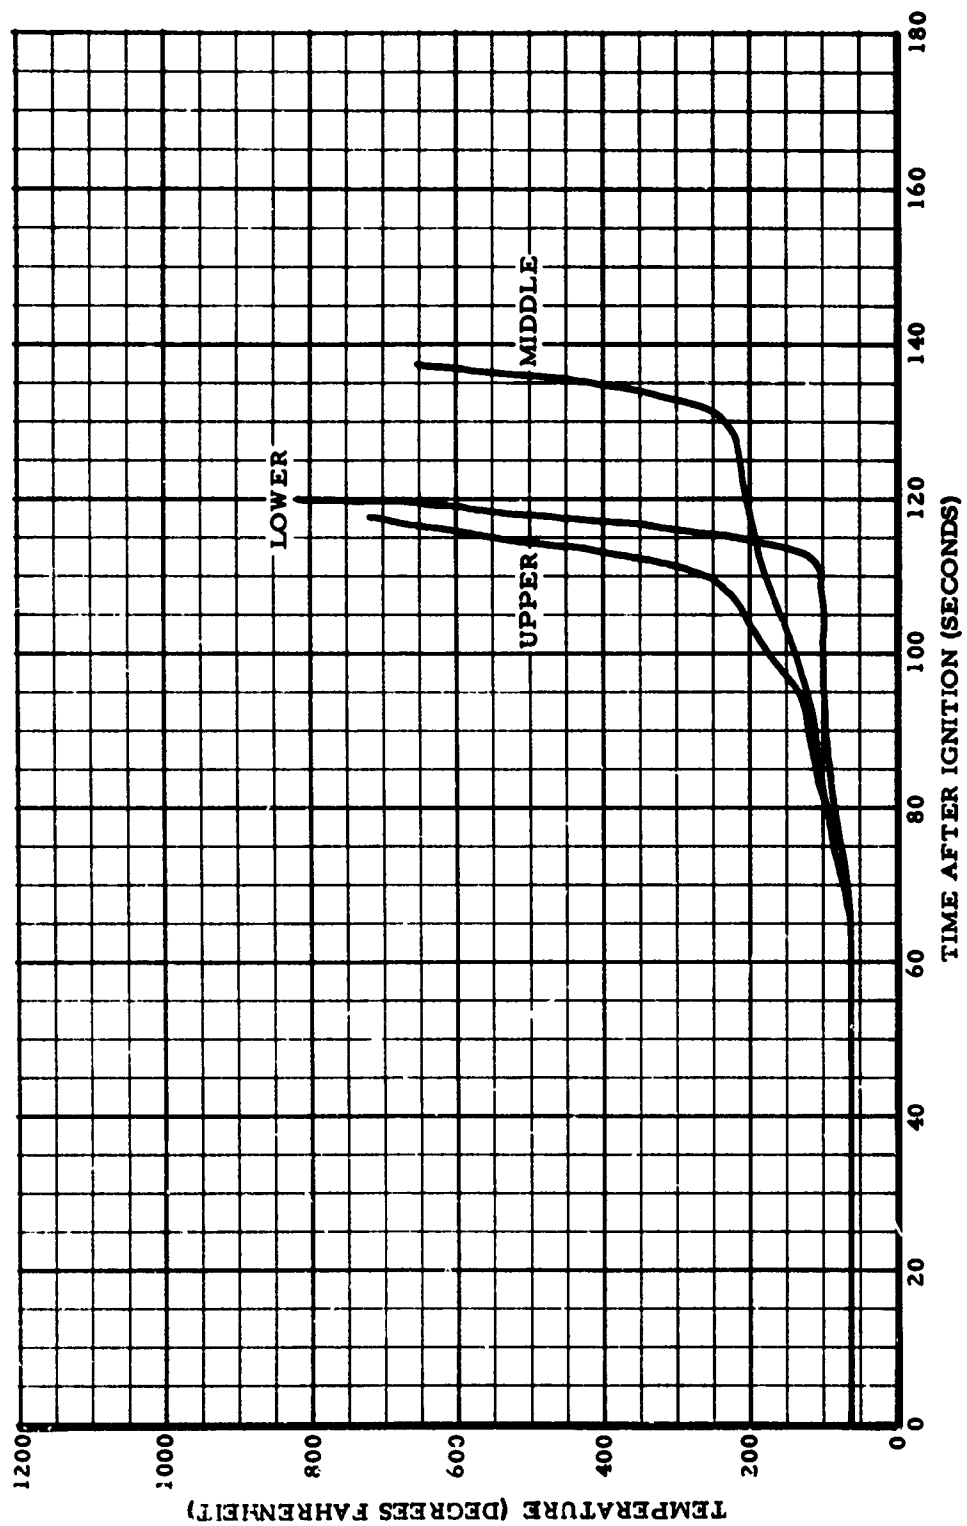
FIGURE 26 - TITANIUM FUSELAGE CABIN WALL TEMPERATURE (CENTER SECTION) DURING AN EXTERNAL FUEL FIRE

Thermocouple data at the cabin wall of the center section are shown in Figure 26. At about 65 seconds after ignition all three thermocouples began to detect heat. During the initial heating, when the increase in cabin wall temperature was fairly gradual, the highest temperature was near the ceiling and decreased toward the floor. Also, a comparison of these data with Figure 25 indicates that the cabin wall temperature always exceeded the insulation temperature. This behavior was also observed at the other two sections. Both observations tend to prove that the cabin wall was being heated by the cabin air--not by heat transfer from the external fuel fire. The rapid increase in wall temperature was caused by the flash fire within the cabin. Figure 27 shows the cabin air temperature measured by the three thermocouples located 6 inches below the ceiling. The early and swift heating of the cabin environment was believed to have been caused primarily by flaming at the panel interfaces, with vent flaming and heat transfer through the uninsulated area at the aft end being minor contributions. The air temperatures were highest toward the aft end of the fuselage, as was the degree of damage to interior materials.

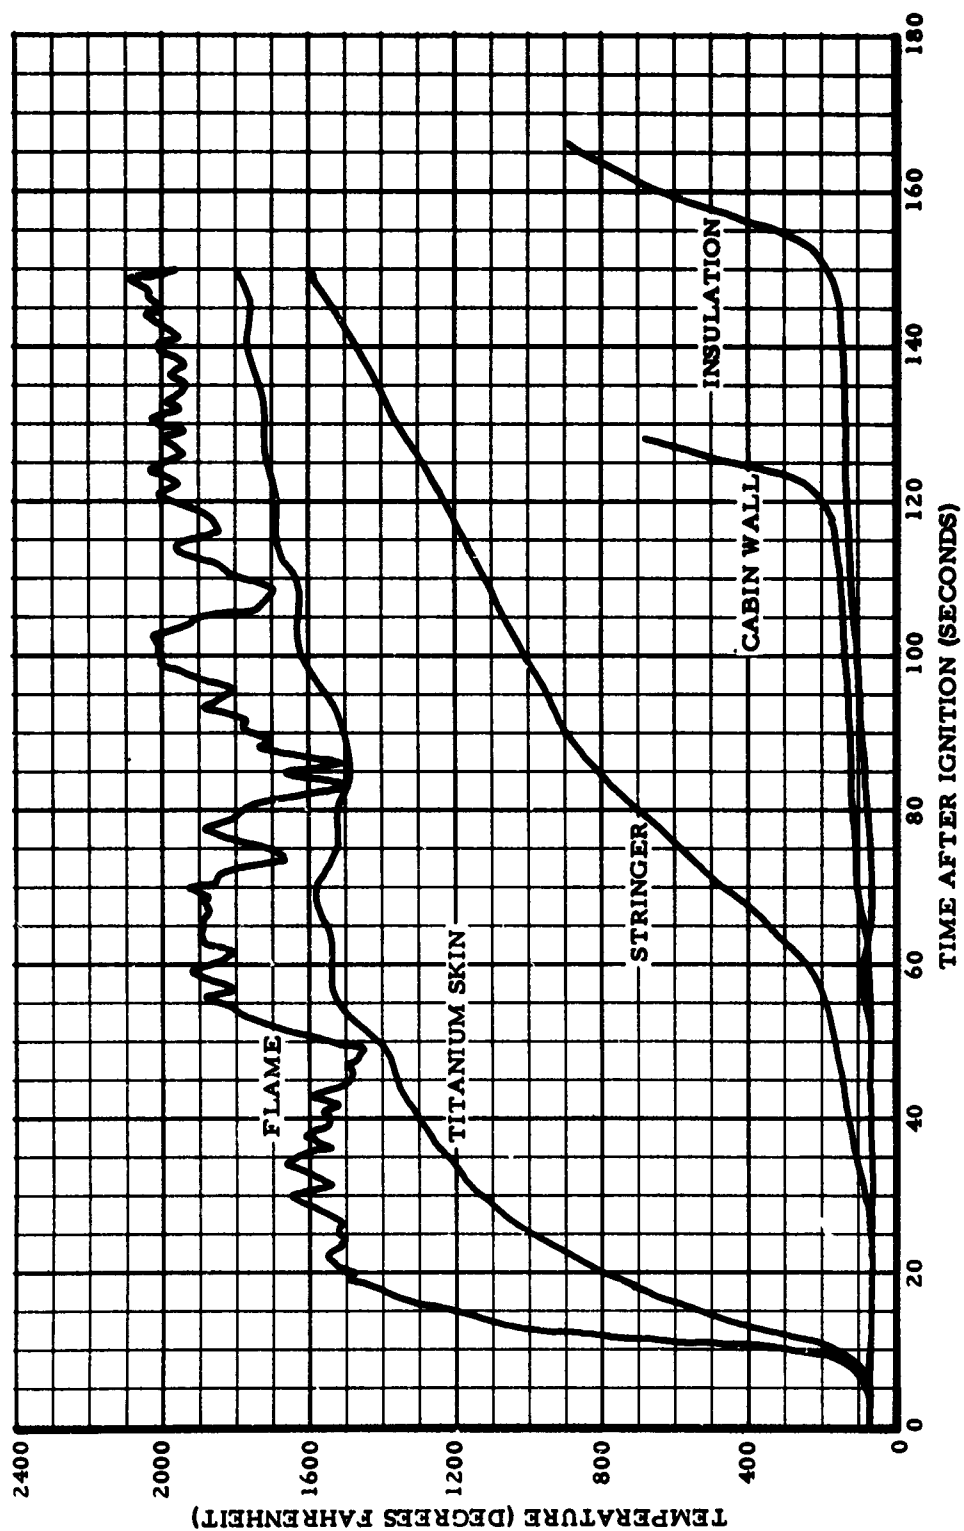
FIGURE 28 - TITANIUM FUSELAGE TEMPERATURE (AFT SECTION, MIDDLE GROUP) DURING AN EXTERNAL FUEL FIRE

A better perspective of the heating of the titanium fuselage is provided by Figure 28 which shows temperature data from the middle group of thermocouples at the aft section. The titanium

skin and stringer were heated by the external fuel fire, with the skin temperature always exceeding the stringer temperature. If the direction of heat transfer was uniformly from the fire to the cabin, it is obvious that the insulation temperature should have exceeded the cabin wall temperature for the duration of the test. Since the cabin wall and insulation temperatures exhibited just the opposite behavior--except for a short time increment about 60 seconds after ignition when the insulation thermocouple was apparently detecting the combustion of RTV silicone sealant--it is clear that heat transfer from the fuel fire did not directly cause the rapid cabin heating. Of course, the fuel fire was indirectly responsible because it heated the RTV silicone sealant and silicone-bonded insulation which decomposed and burned within the cabin environment. Figure 29 shows data from the upper group of thermocouples at the aft section. At this location the heat from the fuel fire was not nearly as severe as that experienced by the middle group of thermocouples. Note that the cabin air and wall temperatures eventually rose above the stringer temperature. Again the important relationship is that, throughout the test, the cabin air temperature exceeded the cabin wall temperature, which exceeded the insulation temperature, thus providing evidence for the deduced mechanism of early cabin heating.

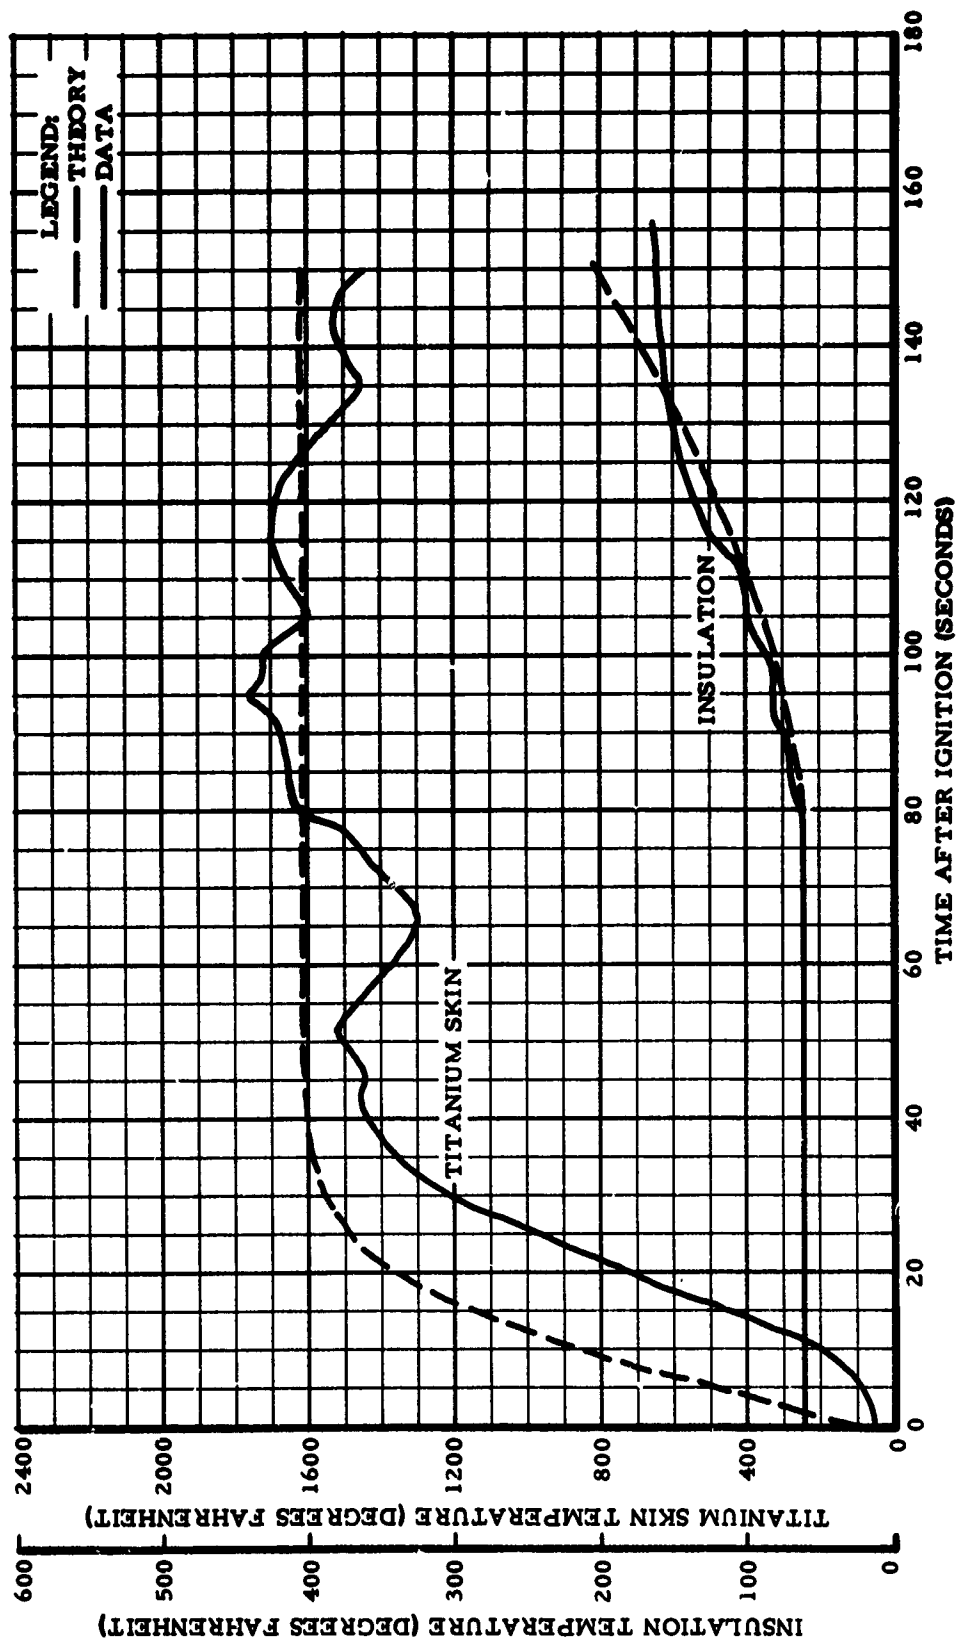
FIGURE 30 - TITANIUM FUSELAGE SKIN AND INSULATION TEMPERATURE DURING AN EXTERNAL FUEL FIRE COMPARED WITH THEORY

Before this test, considerable speculation was being expressed about the protection that could be provided to the passengers within a titanium fuselage during an external fuel fire. One estimate was that "the cabin will stay room-temperature comfortable for 30 minutes in a roaring fire" (Reference 12). However, this test demonstrated that the cabin pressure sealant and insulation, located adjacent to the titanium skin, were potential sources for the generation of smoke and volatile gases which would produce fatal conditions within the cabin in a matter of a few minutes. Actually, if the sealant and insulation were inert, the degree of protection could be considerable, as is explained below. Figure 30 compares the theoretical titanium skin and insulation temperatures (Appendix A) with the experimental data at the center section, middle group. The predicted skin temperature exceeded the data near the beginning of the test, since it was assumed that the radiative heat flux was at its steady-state value right at ignition; i.e., the fire buildup was not accounted for in the theoretical calculations. The steady-state skin temperature, which was a boundary condition for the calculation of the insulation heating, agreed reasonably well with the data. Therefore, any agreement between theory and data for the insulation temperature could be interpreted as signifying the validity of the calculation procedure. This agreement is amazingly evident in Figure 30, but

is misleading for several reasons. First of all, the insulation thermocouple, as was previously explained, was partially measuring heat from silicone combustion. Secondly, the predicted insulation temperature is conservative (high) since the theoretical model did not consider the heat sink capacity of the structural members, nor the heat transfer from the titanium skin to the reflective polyimide film which encapsulated the insulation. Therefore, the insulation temperature for a titanium fuselage constructed with inert insulation and sealant would be somewhere below either the theoretical or experimental curve shown in Figure 30. The cabin air temperature, assuming the prediction method to be valid, will thus be less than the prediction curve shown in Figure 1-6. It is apparent that a titanium fuselage without windows exposed to a roaring fire could provide a safe cabin environment for a significant time if the sealant and insulation are inert. The exact time can only be established by experiment, but is, at the very least, 5 minutes.

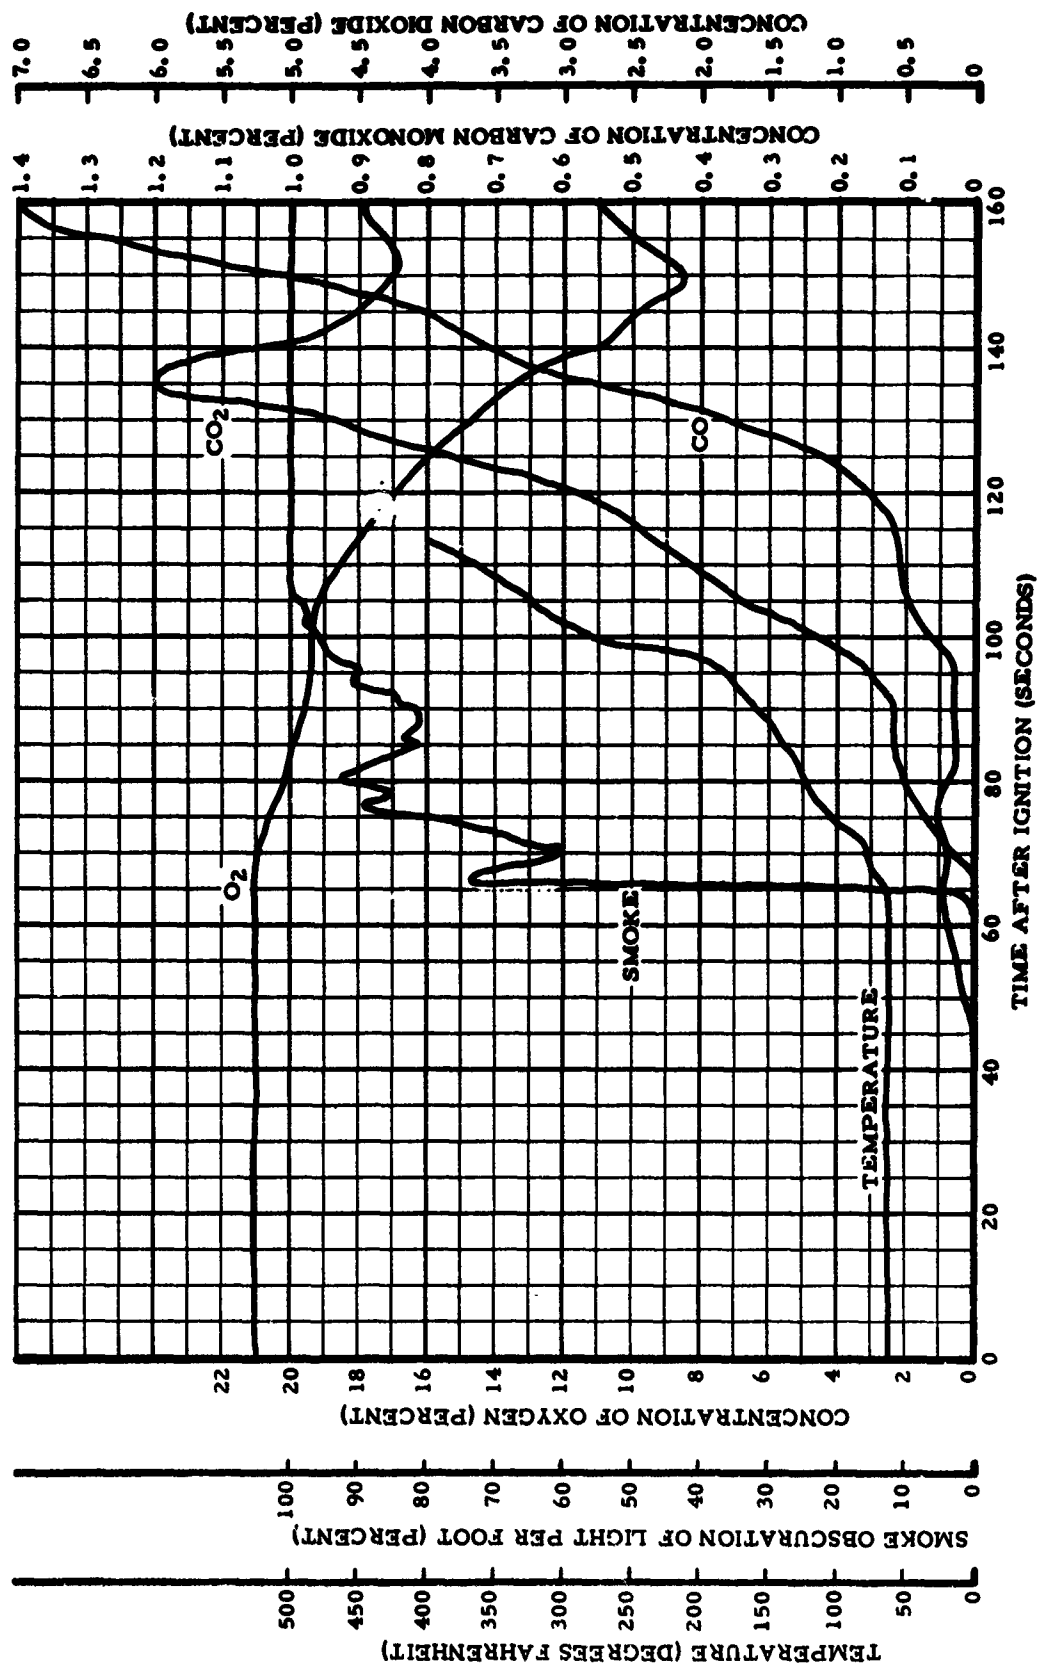
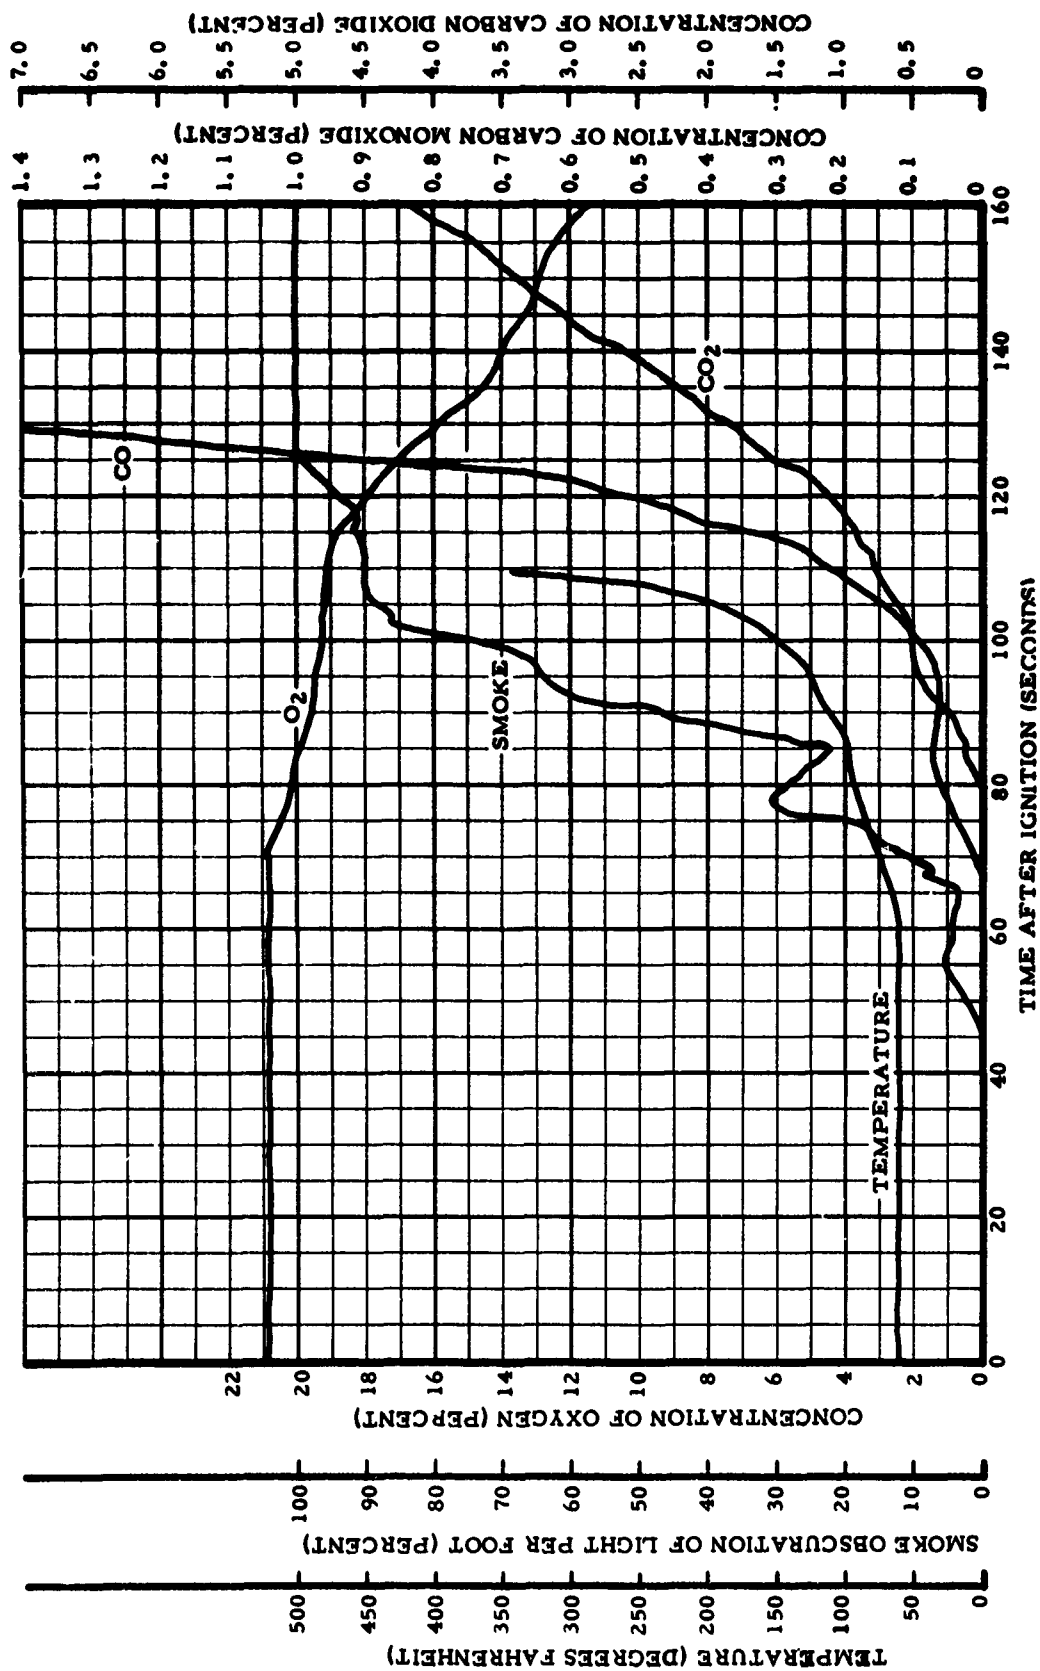
The environmental conditions at the two gas-sampling locations are shown in Figures 31 and 32. Both smoke near the window and carbon dioxide below the ceiling were detected before the cabin air showed any measurable increase in temperature. The density of smoke, as measured by the obscuration of light across a distance of 1 foot, showed the most drastic change, especially below the ceiling. Both smoke meters indicated total obscuration by shortly after 2 minutes. Generally, carbon monoxide and carbon dioxide increased significantly at both sampling locations shortly after 1 minute from ignition, and were accompanied by a decrease in oxygen. From a safety viewpoint, the presence of smoke offered the first obstacle against survivability. It would have been initially manifested by a decrease in visibility accompanied by an undeterminable amount of panic. Severe exposure to smoke also causes physiological effects which, similar to the psychological effects, have yet to be qualitatively or quantitatively defined. After the effects of smoke, a passenger would have next been hampered by the high cabin air temperatures. As indicated by the cabin wall temperature shown in Figure 26, the cabin air surpassed at least 800°F, and, judging by the slope of this curve, probably reached a considerably higher temperature. Tests at NAFEC showed cabin air temperatures reaching 1600°-1700°F during a flash fire (Reference 13). Exposure to temperatures of this level would cause unbearable pain and death in a matter of seconds (Reference 13). The concentrations of carbon monoxide, carbon dioxide and oxygen, each taken individually, would have only produced minor toxic effects (Reference 14) up to the fatality time governed by air temperature (approximately 2 minutes).
